Monitoring of a Historical Masonry Structure in Case of Induced Seismicity

Ihsan Engin Bal, Dimitris Dais, Eleni Smyrou & Vasilis Sarhosis

^aResearch Center for Built Environment NoorderRuimte, Hanze University of Applied Sciences, Groningen, The Netherlands; ^bSchool of Civil Engineering, University of Leeds, Leeds, UK

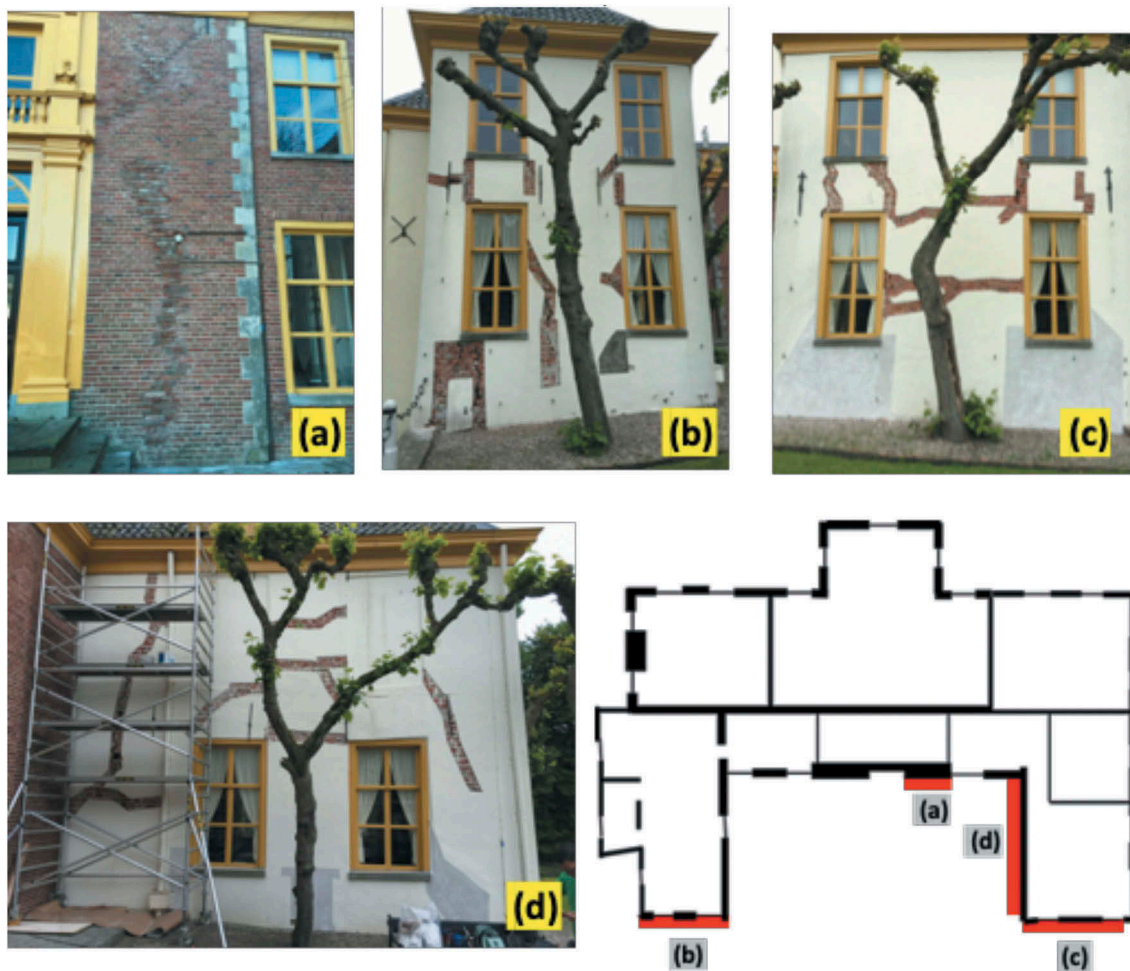
Although the increased seismic activity went hand in hand with increased number of cracks, the shape and location of latter did not resemble earthquake-related cracks. Most of them were in vertical direction, with a larger width close to the base and smaller widths in higher elevation, while diagonal X-shaped cracks, the standard sign of in-plane masonry response to lateral earthquake loading, were not observed in the structure. The existing cracks reminded more cracks caused by soil movements rather than by seismic load. After the end of restoration, the manifestation of new cracks in the summer of 2018 in the most problematic part of the structure, i.e. the façades of the NW wing (Figure 5), was a puzzlement given the relative limited seismic activity in the respective period. However, after monitoring results have been combined together with finite element analyses and observations in the field, it was possible to reach a plausible explanation for the old (prior to 2015

Figure 3. Cracks registered during 2015 restoration, and the red lines on the right-corner plan view denote external walls subjected to damage.

The point of this numerical exercise is to show distribution of cracks derived after the combination of two actions. In more detail, when settlements are applied, concentration of damage is observed at the wall shown in Figure 3d and beneath the tower. After the superposition of seismic load, further damage appears at the walls as also shown in Figure 3a–c.

from the structure. Structural damage and cracks were observed in an increasing pace between 2014 and 2015. The 2015 restoration included interventions on the front façade of the structure where extensive cracks had been formed (Figure 3), while the cracks on the internal walls of the structure were repaired during the 2017 restoration. These cracks were mostly vertical and partly horizontal and diagonal, concentrated on the Northwest (NW) wing as well as on the front façade of the middle zone (see Figure 1) of the structure. The cracks were as wide as a couple of millimetres in some regions. The plaster was removed and the damaged bricks were replaced during the 2015 restoration.

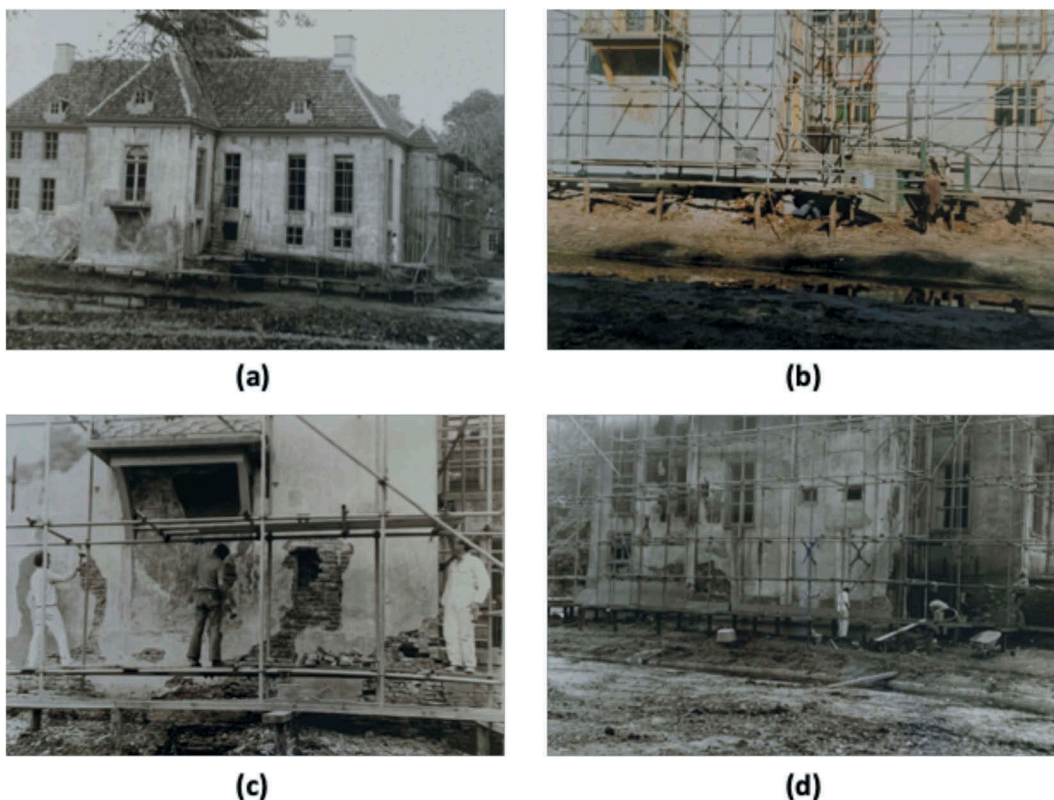
The structure went through a serious renovation in 1973, including structural interventions in the retaining walls outside as well as in the floors and connection details inside the building. There is no written report from that period, but photographs of a personal archive have been used to identify the nature of the structural interventions. As shown in Figure 4, bricks from damaged masonry walls were removed and replaced; however, the cause of these damages is unknown. The foundations at the perimeter of the building are also made of brick masonry. They were repaired by using new bricks. A reinforced concrete floor was added above the main entrance, right below the tower. Steel profiles were added at the base of the tower to stabilize it. Finally, all masonry retaining walls were repaired, missing parts were added, and new steel anchors were placed behind the walls.

Figure 4. Photos from the restoration Works in 1973, (a) A general view from the building under restoration, (b) Works at foundations along the perimeter, (c) Mason works on the brick walls, and (d) Works on the walls and the foundations.

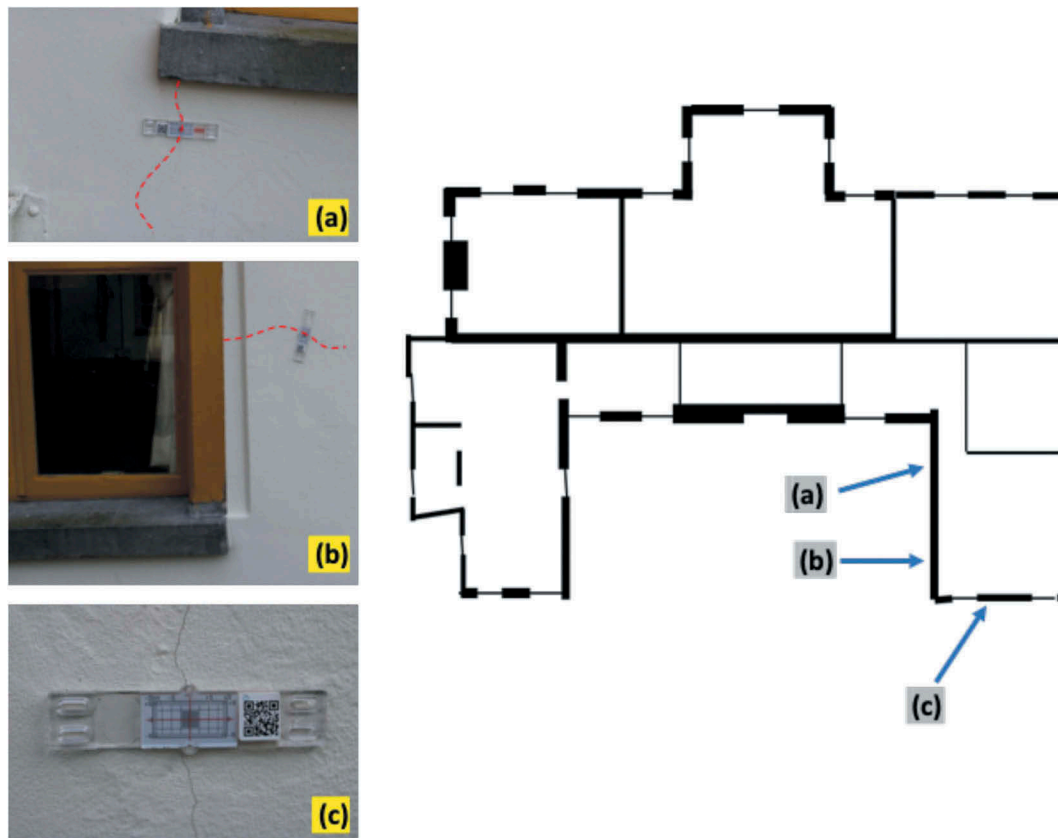
Although electronic displacement sensors (potentiometers) were designed for monitoring existing or potential cracks, their installation was avoided due to aesthetic concerns. Instead, crack rulers (see Figure 5 for a clear close-up photo) were placed in January 2019 and monitoring takes place by regularly photographing these crack rulers since then. No movement has been detected since January 2019.

Figure 5. Minor cracks appeared in August 2018 (left) and their locations on the plan view (right).

The tiltmeter data, in combination with the accelerometers data from 8th of August 2018 event, indicate that the foundation of the NW wing and the soil beneath have played an important role in the cracks that appeared in August 2018. It is difficult to explain the exact contribution of soil-related parameters since fundamental data, such as the potential existence and the situation of piles, are unknown. Speculation about possible explanations regarding the soil effects is provided below.

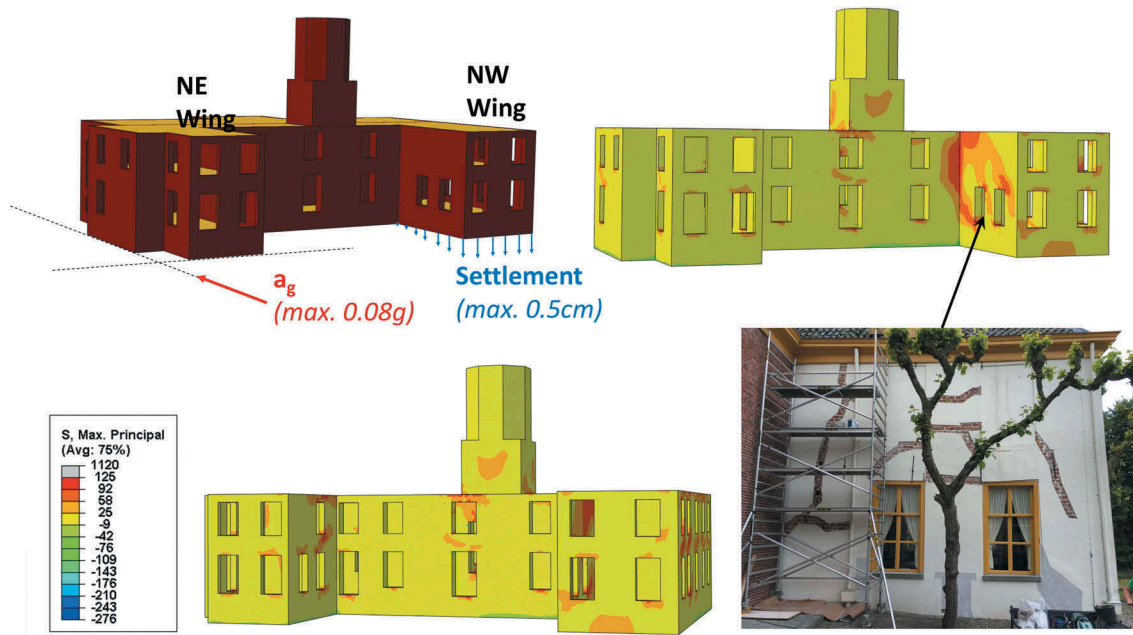
applied in that wing analytically. In particular, a 0 to 0.5 cm vertical settlement is applied on the NW wing (i.e. 0.5 cm at the edge, 0 cm at the connection with the main zone) and the response of the structure is shown in terms of tensile maximum principal stresses (Figure 13). In case of the scenario of only-settlement, although some of the cracks prior to the renovation and repair in 2015 (Figure 3) were captured, the results were not satisfactory in overall. Match between the damage distribution and the observed damages was not achieved. When an earthquake load is applied in conjunction with the settlement, the location of the cracks in the NW wing and at the front façade of the main zone were captured successfully (see the comparison in Figure 13). The earthquake load is applied as incremental lateral equivalent static force proportionally to the mass and from 0 to 0.08 g. The earthquake load is applied in the short direction of the structure because this was the dominant direction of the 2015 Hellum Earthquake of ML 3.1 (i.e. the direction perpendicular to the travel path). Hellum Earthquake was reported as the reason of the damages in the structure in 2015 and the crack photos presented in Figure 3 belong to a period right after that earthquake.

Figure 13. Distribution of maximum principal stresses from the nonlinear static analyses in the scenario of 0.5 cm maximum vertical settlement at the NW wing superposed with lateral earthquake equivalent static load of 0.08 g and comparison with the observed damages after 2015 Hellum Earthquake.
